Kochi Chapter

Indian Geotechnical Conference

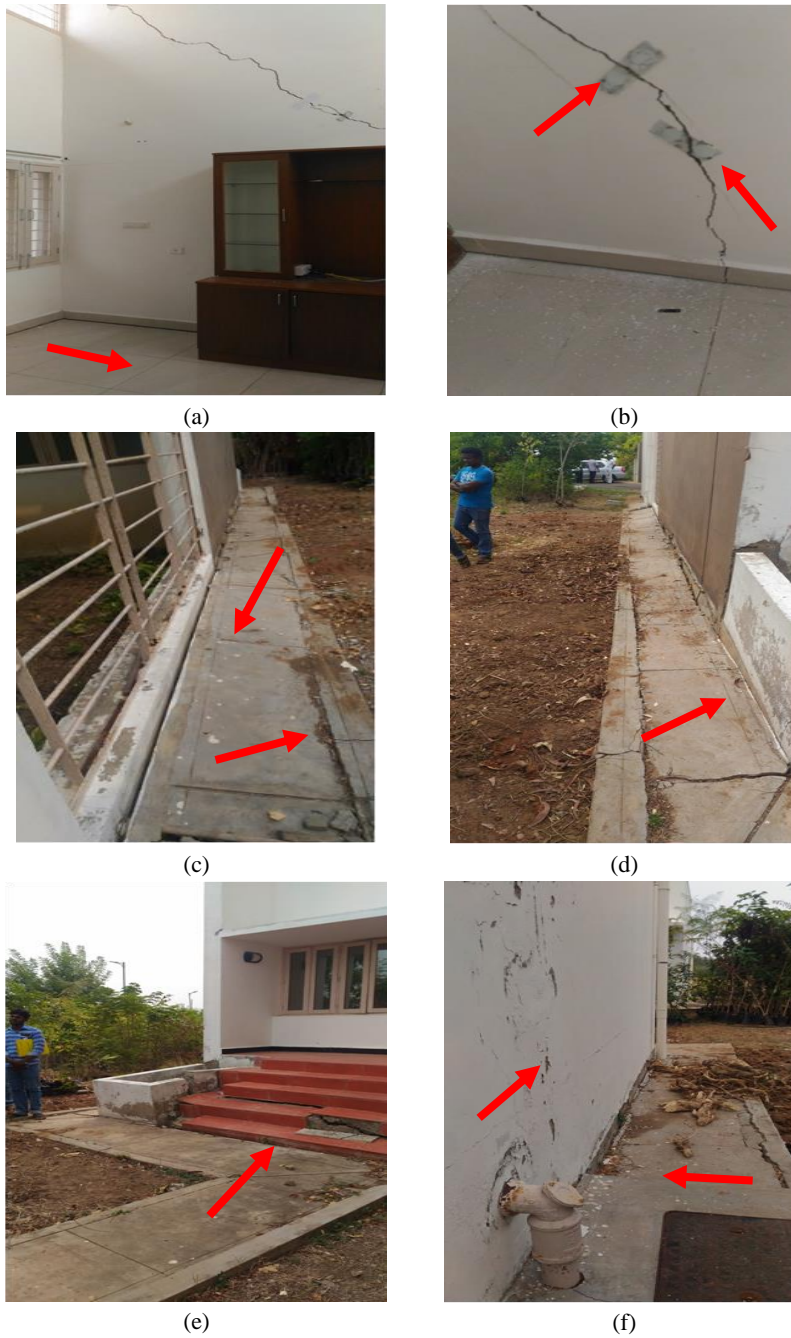
Fig.1 (a) View of caving-in of vitrified tiles and (b) diagonal wall cracks in the inner portion living room area; (c),(d) Caving-in of the plinth protection slab southern side (e) Damages of platform and footstep of eastern portion of the building (f) Views of wall crack and caving-in of plinth protection slab on northern side

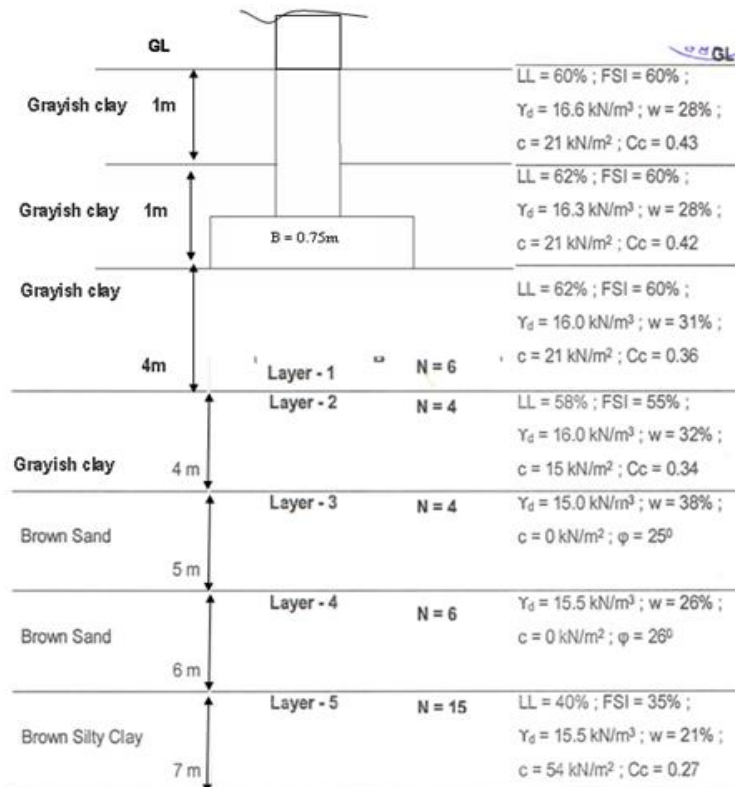
Fig.2 Soil profile below foundation (worst soil profile from BH1 to BH7)

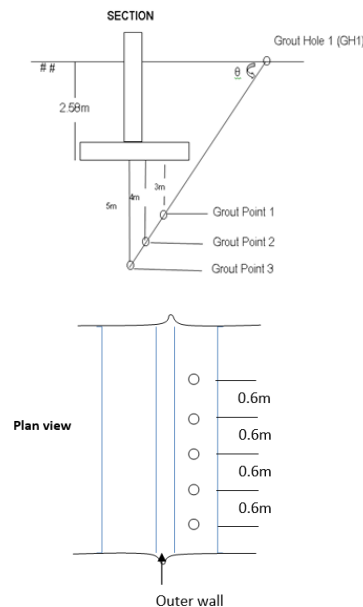
Fig.3 Schematic view of pressure grouting to be executed at the distressed site

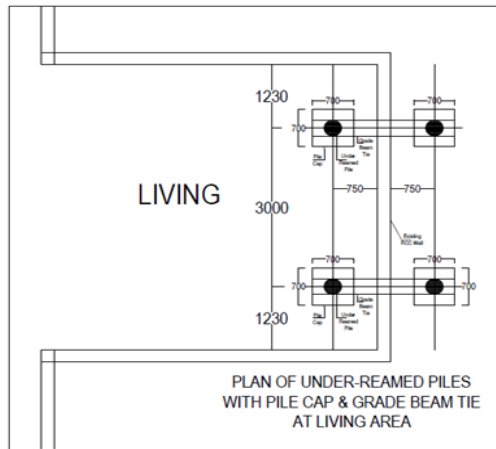
Fig.4 Plan of Under- Reamed piles with pile cap and grade beam tie at living area

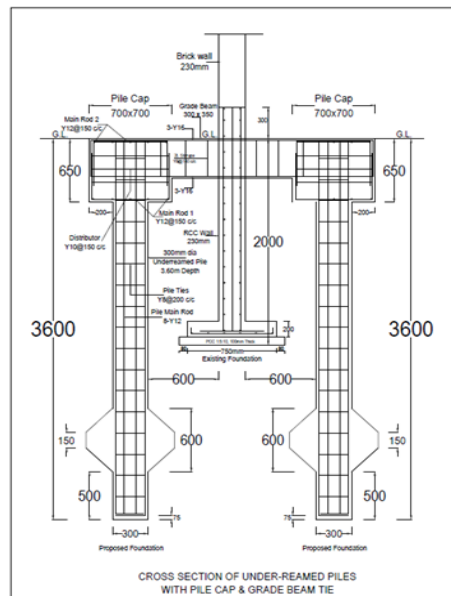
Fig.5 Cross section of Under- Reamed piles with pile cap and grade beam tie
